Review of Modern Nondestructive Testing Techniques for Civil Infrastructure

**Problem Report submitted to the
Benjamin M. Statler College of Engineering and Mineral Resources
at West Virginia University
in partial fulfillment of the requirements
for the degree of**

**Master of Science
in
Civil Engineering**

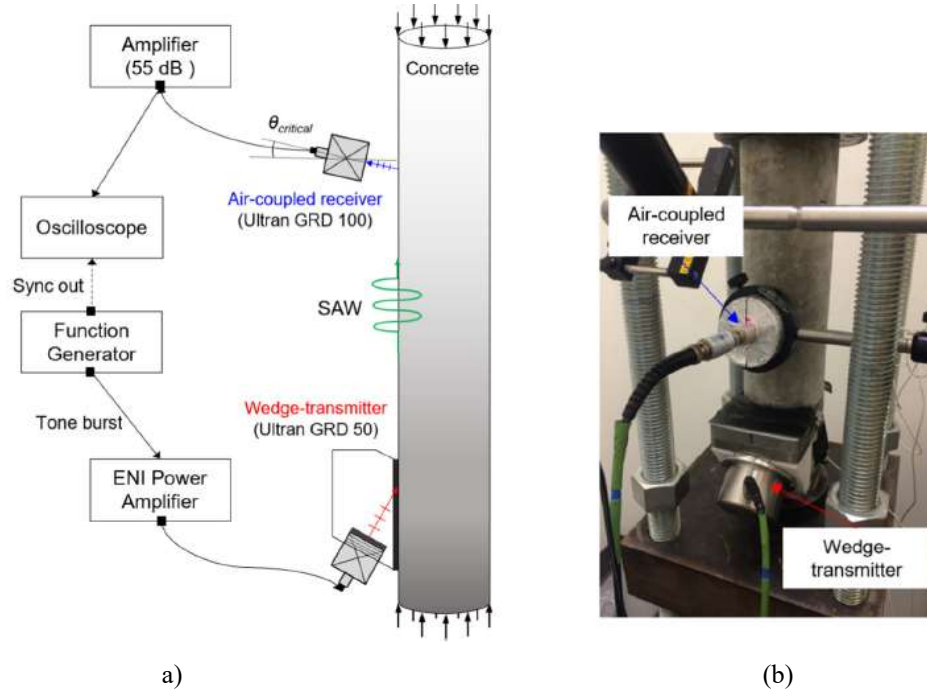
Figure 3.28: (a) Schematic diagram of SHG setup for concrete cylinders; (b) SHG setup (Kim et al. 2018).

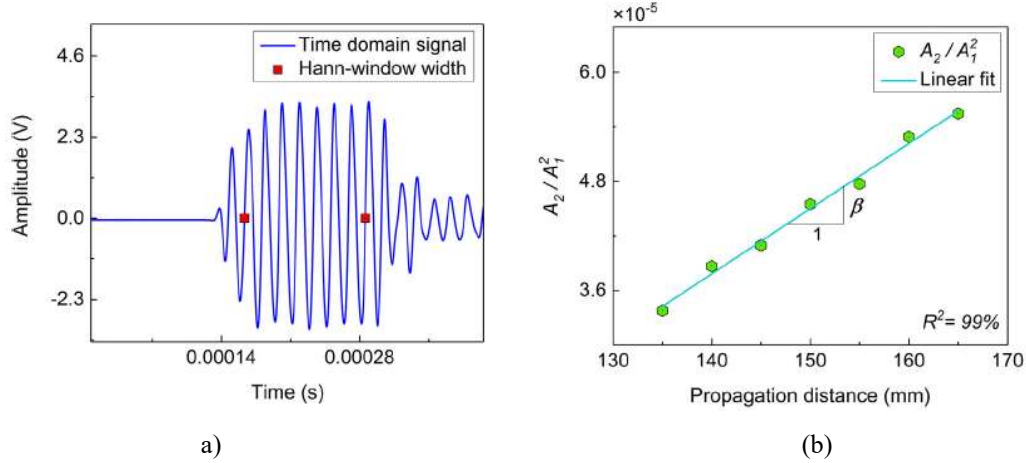
Figure 3.29: SHG measurement results under creep: (a) Time domain signal for concrete specimens; (b) β as a slope of the plot (Kim et al. 2018).

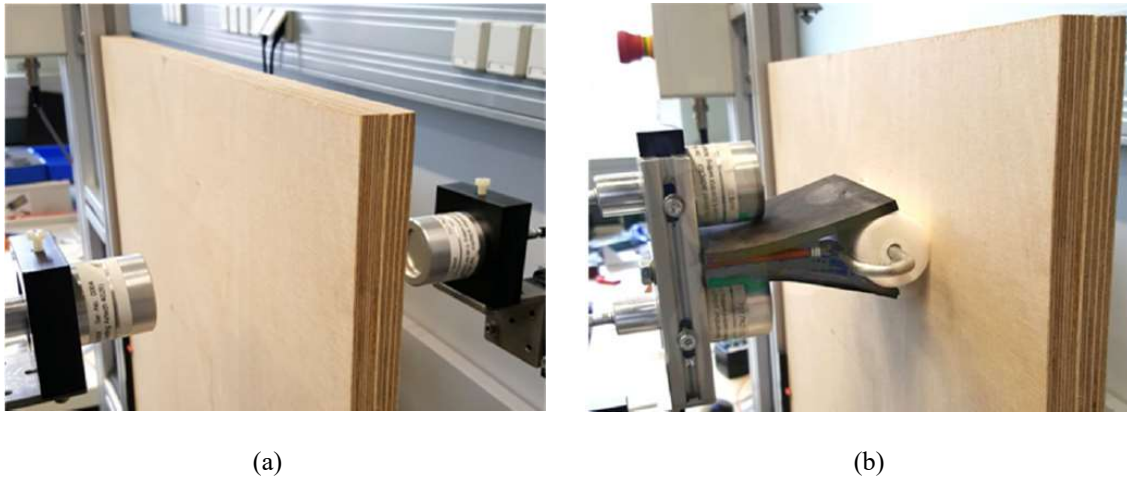
Figure 3.31: (a) Through transmission; (b) reflection techniques setup (Vossing et al. 2020).

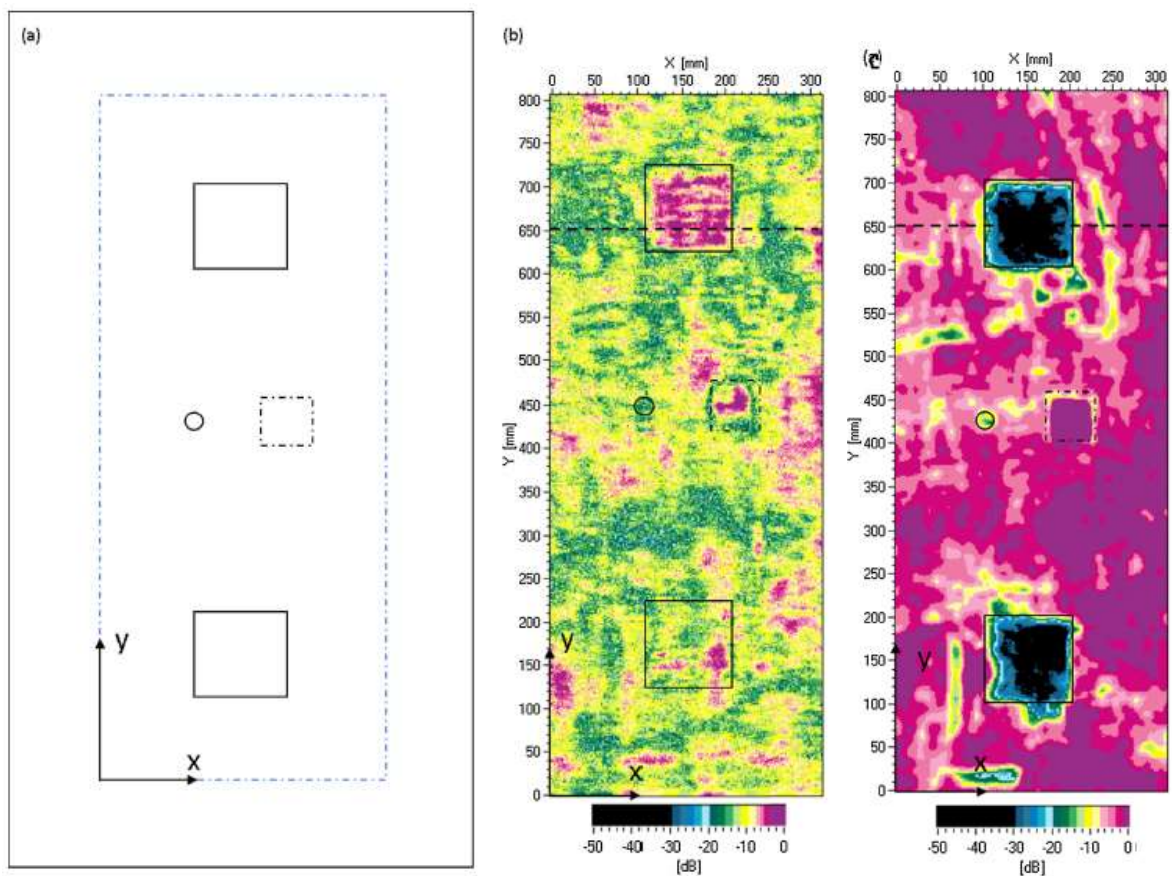
Figure 3.32: (a) Multiplex sample with top three millings and bottom delamination; (b) C-scan of the sample in reflection mode; (c) C-scan of the sample in transmission mode (Vossing et al. 2020).

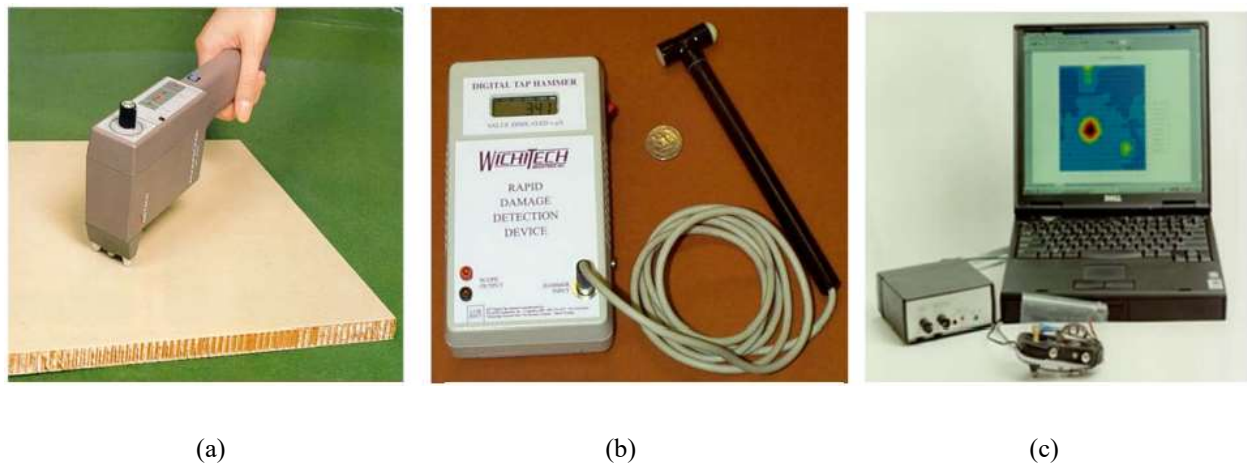
Figure 4.2: DTT devices: a) Woodpecker; b) RD3; c) CATT (Poveromo 2015).

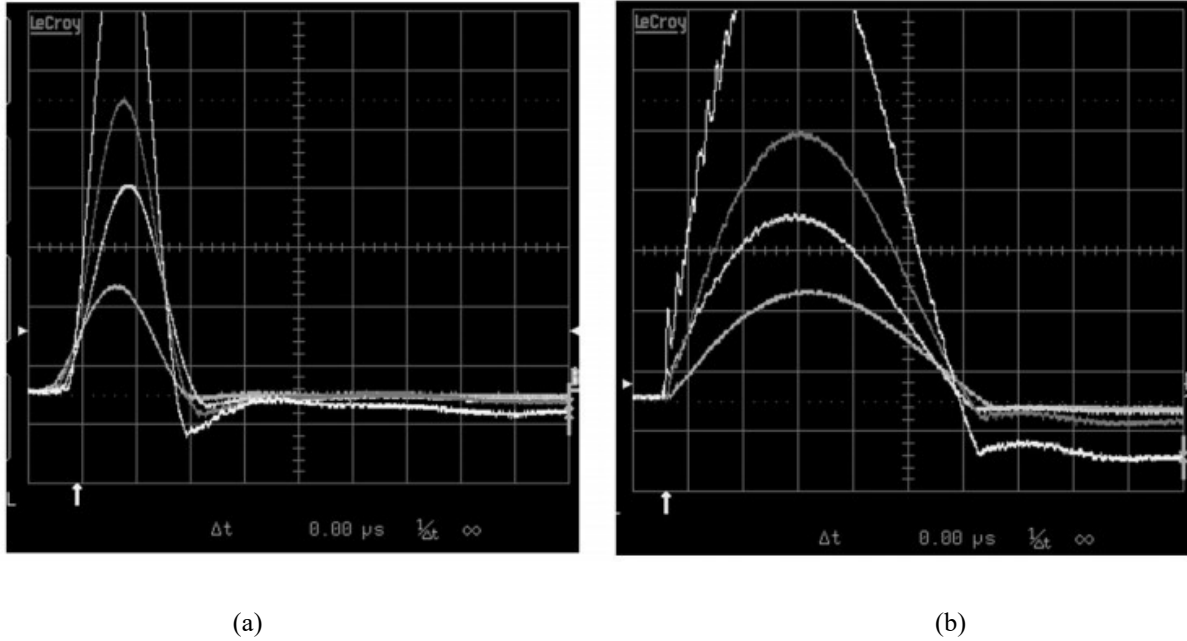
Figure 4.3: Different levels of force vs. time curves for (a) good area; (b) bad area (Hsu et al. 2009).

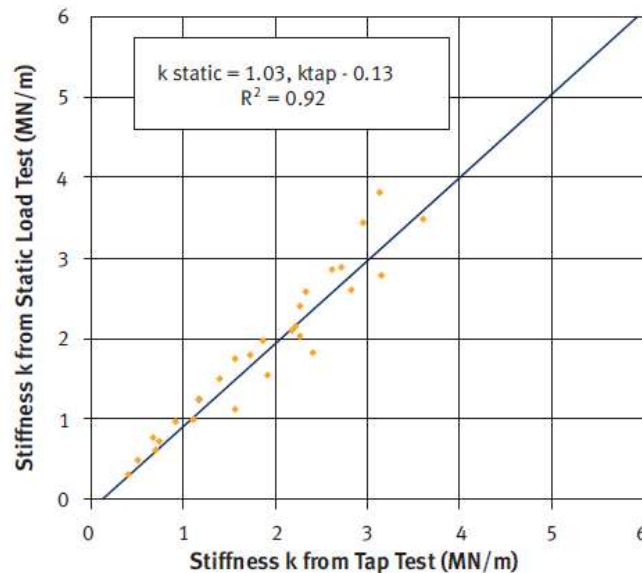
Figure 4.4: Linear regression curve for stiffness computed from the Static Load Test vs. the Tap Test (Hsu et al. 2009).

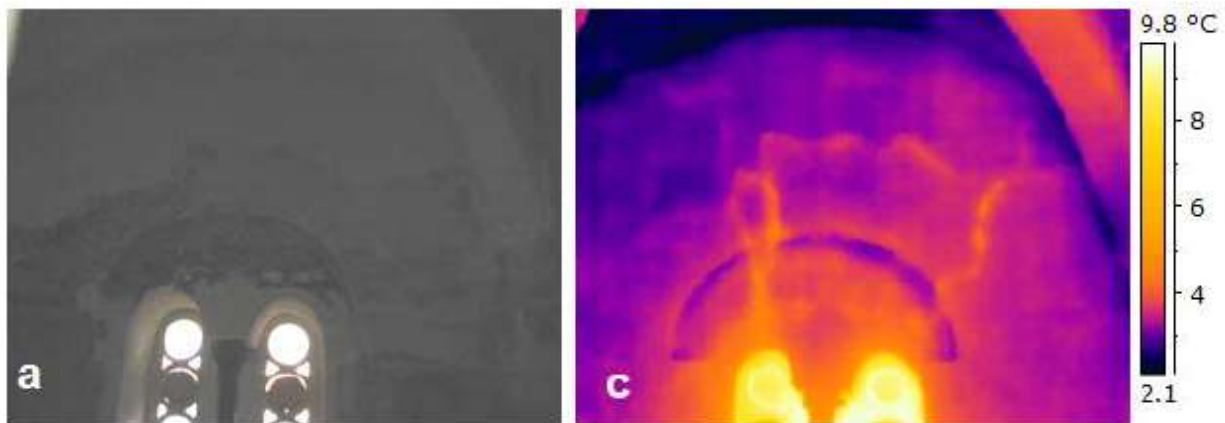
Figure 4.6: (a) St. Savior Tower wall with corresponding thermogram (Ristic and Polic-Radovanovic 2013).

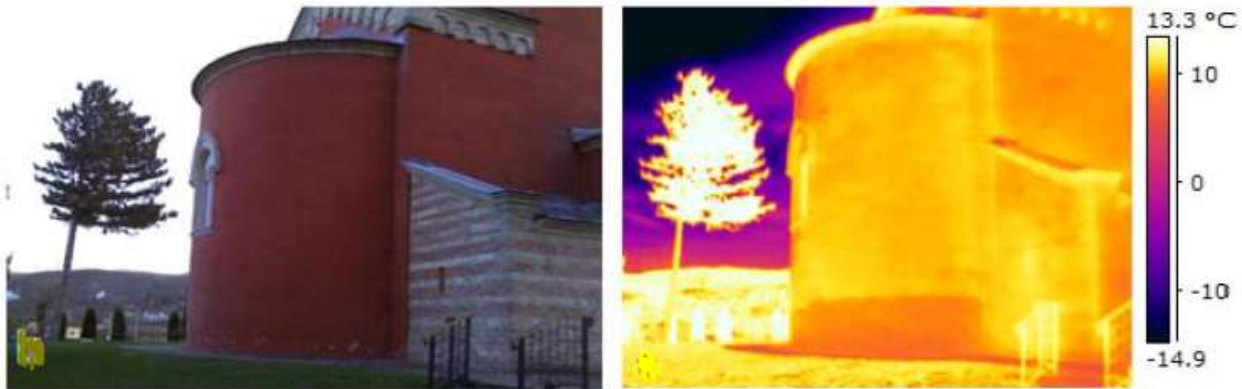
Figure 4.7: Eastern façade with corresponding thermogram (Ristic and Polic-Radovanovic 2013).

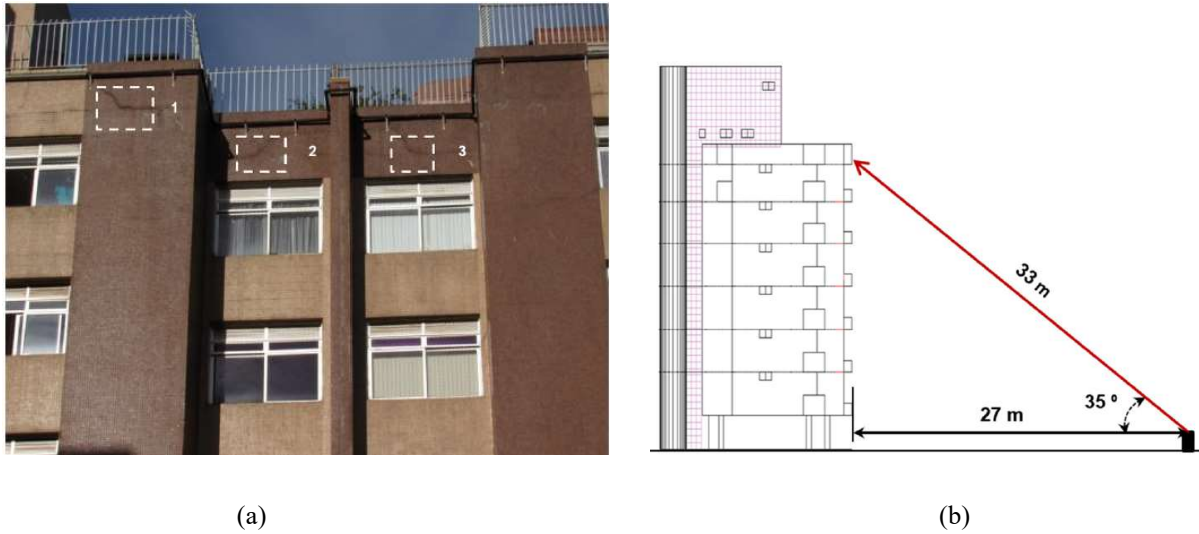
Figure 4.8: (a) IRT target building façade with visible cracks in regions 1, 2, and 3; (b) Data acquisition position of the IR camera (Bauer et al. 2018).

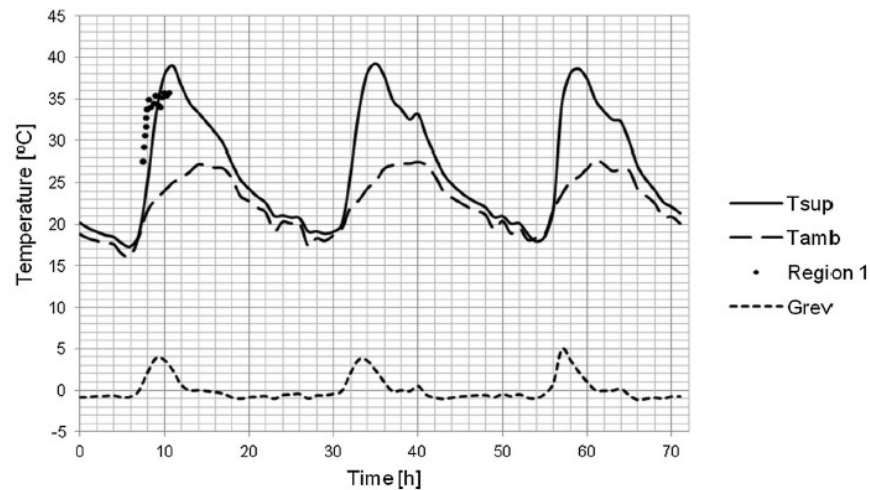
Figure 4.9: Temperature profile over time obtained from the hygrothermal simulation and comparison with IRT data in region 1 (Bauer et al. 2018).

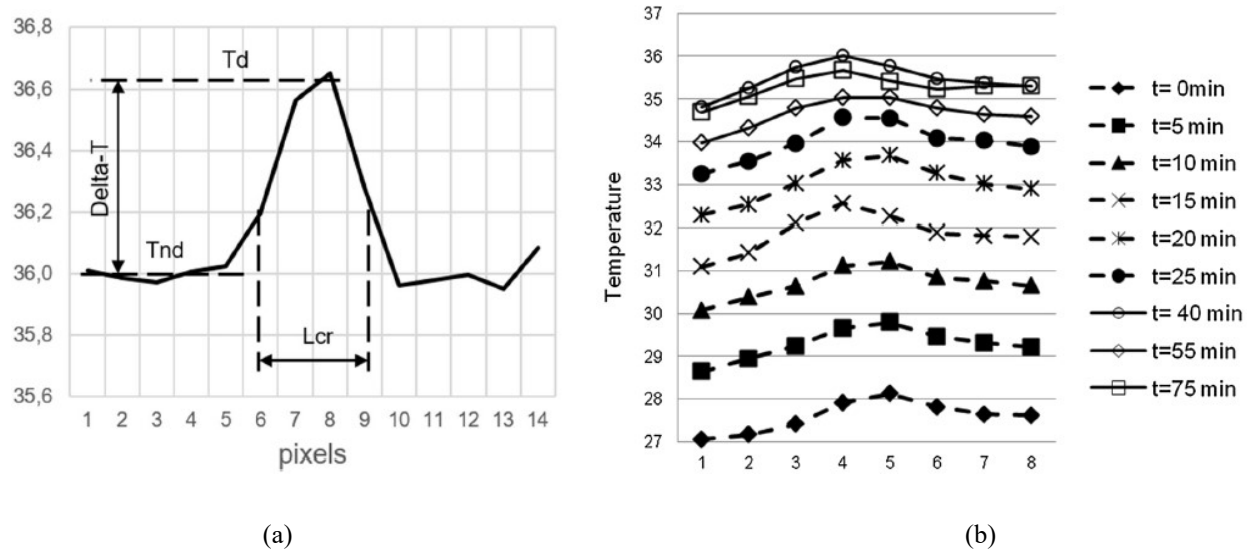
Figure 4.11: Temperature profiles of the pixels along the line perpendicular to the crack obtained (a) as an example; (b) from thermograms of crack 1 (Bauer et al. 2018).

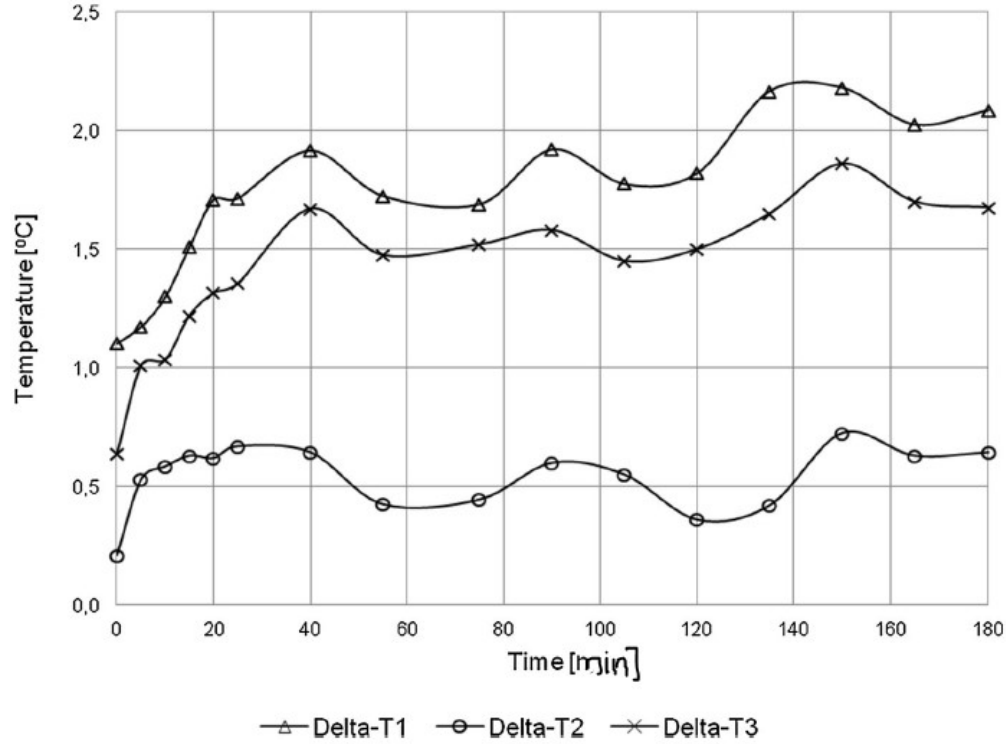
Figure 4.12: Delta-T plots for cracks 1, 2, and 3 (Bauer et al. 2018).

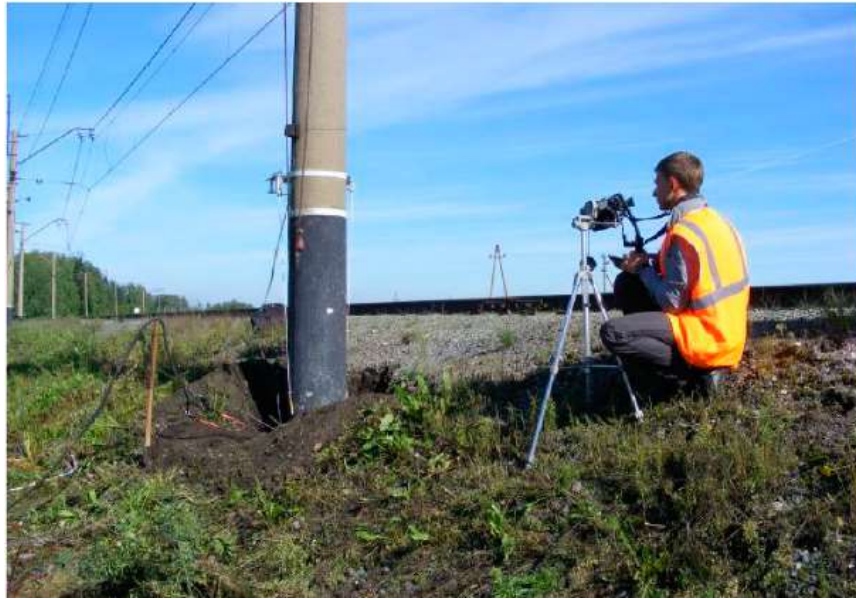
Figure 4.13: Test setup with a target length of 1 m marked by the aluminum strip (Sannikov et al. 2018).

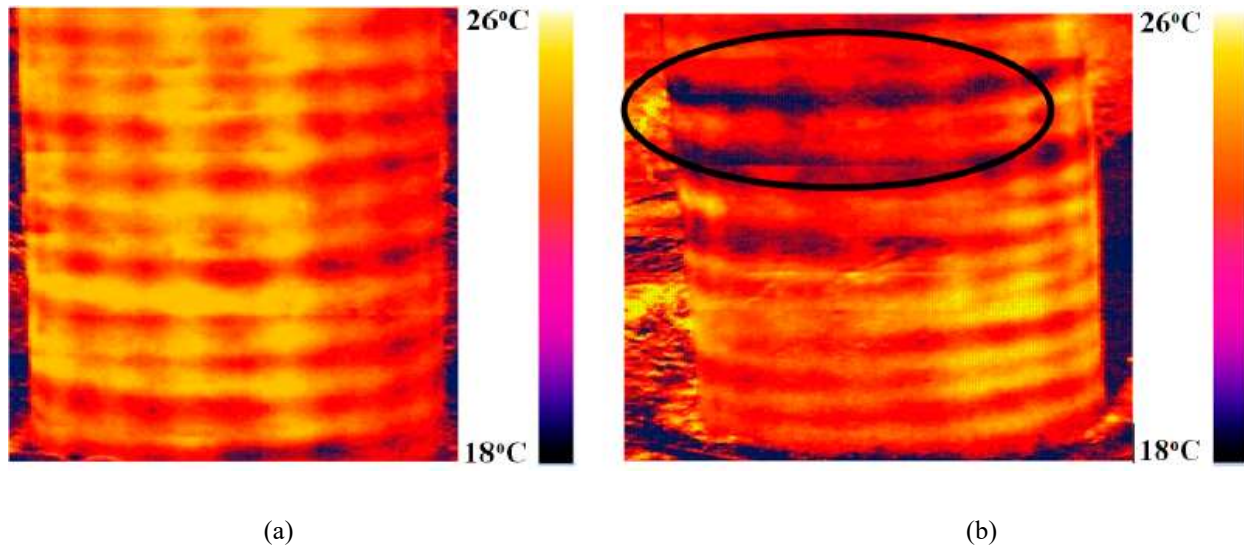
Figure 4.14: Maxigrams of the pole section above the ground level from (a) a defect-free area; (b) damaged area (Sannikov et al. 2018).

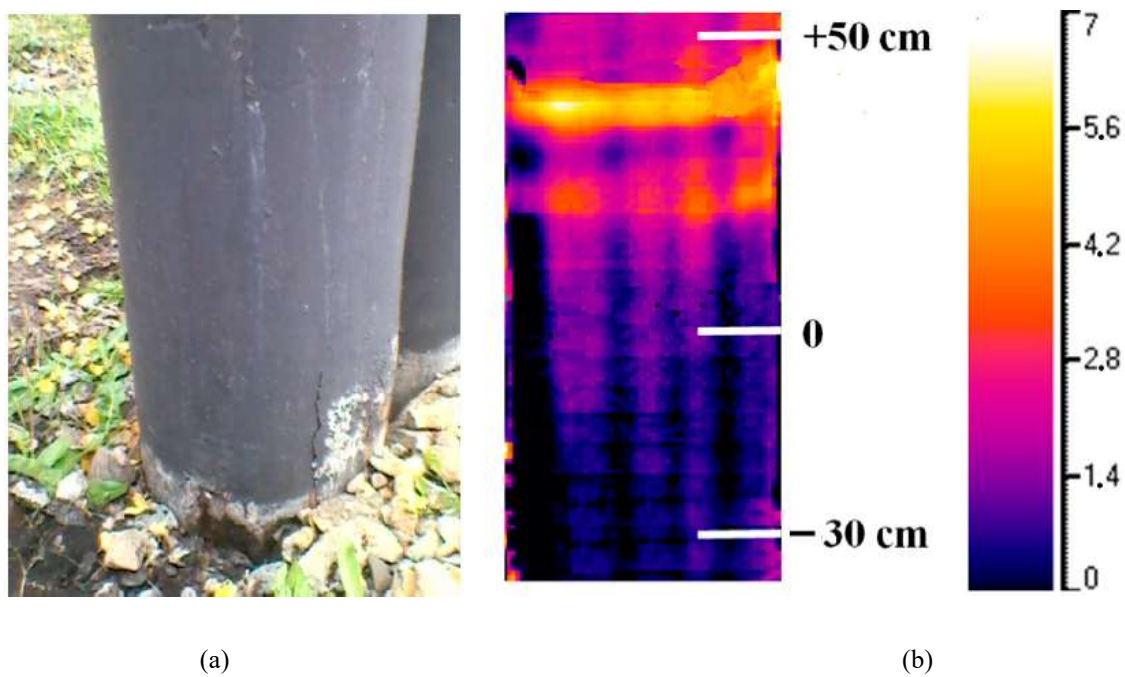
Figure 4.15: (a) Assessment of the pole section below the ground level; (b) Maxigram of the section (Sannikov et al. 2018).

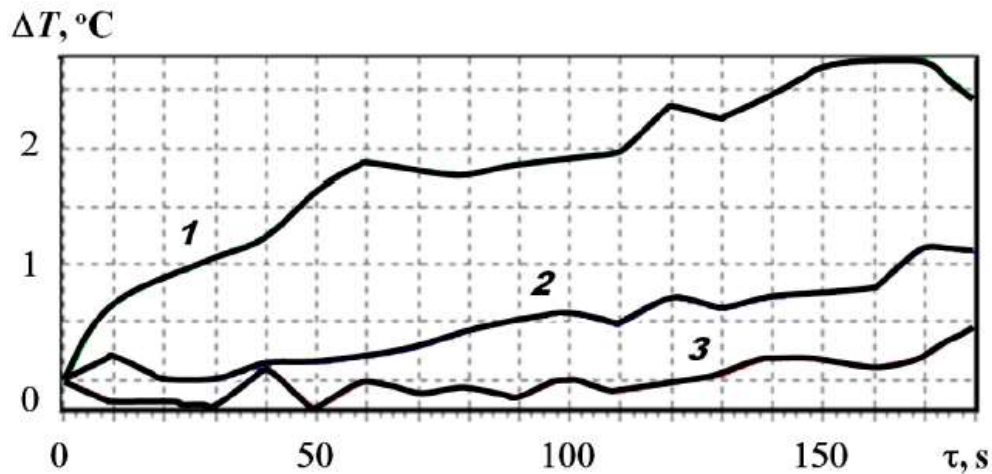
Figure 4.16: Maximum ΔT rate for pole sections (1) 50 cm above the ground level; (2) at the ground level; (3) 30 cm below the ground level (Sannikov et al. 2018).

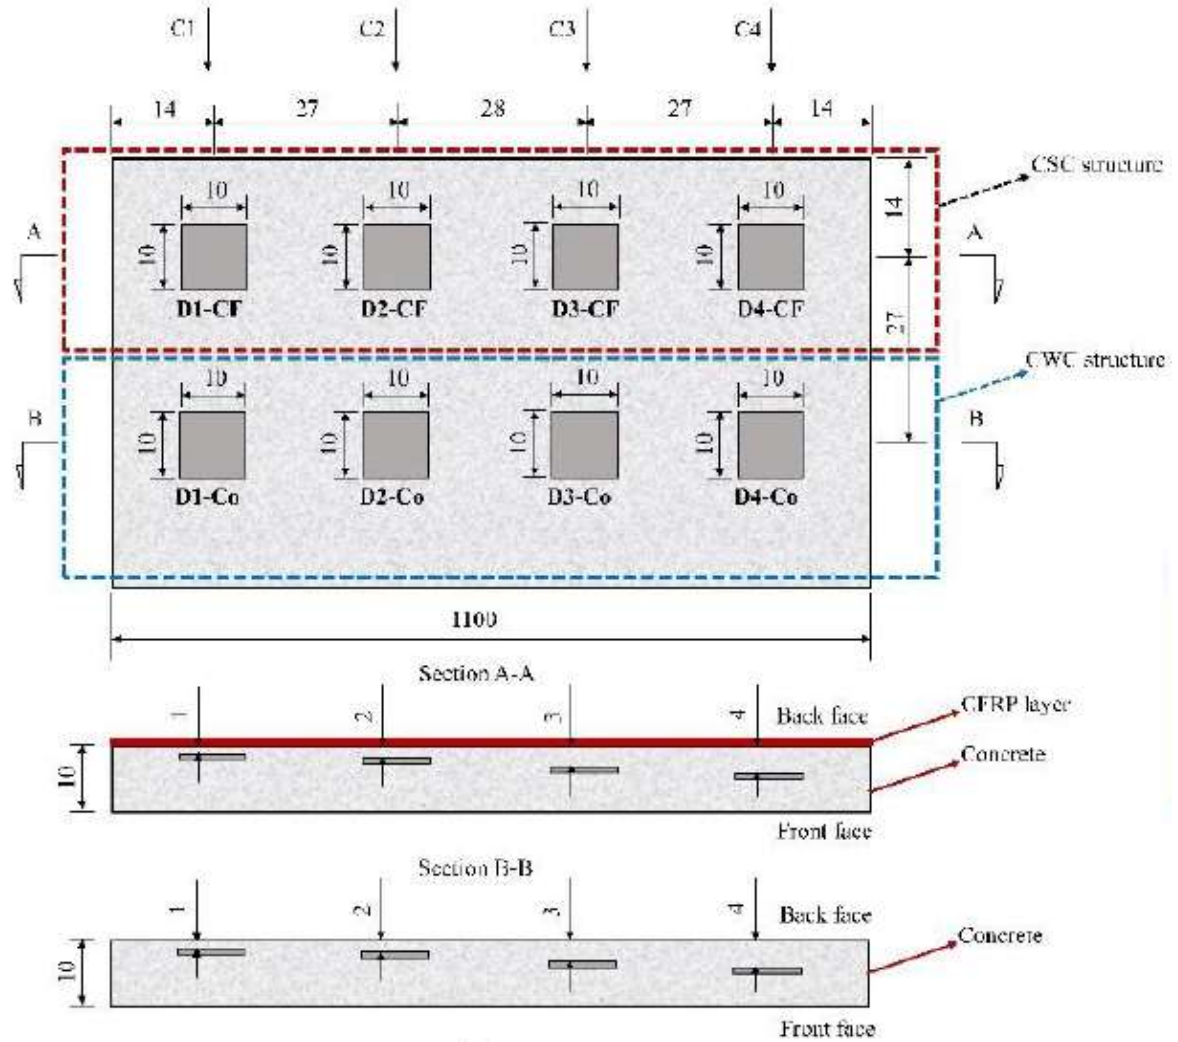
Figure 4.17: Concrete specimen with artificial delaminations arrangement with and without CFRP sheets installed (Mac et al. 2020).

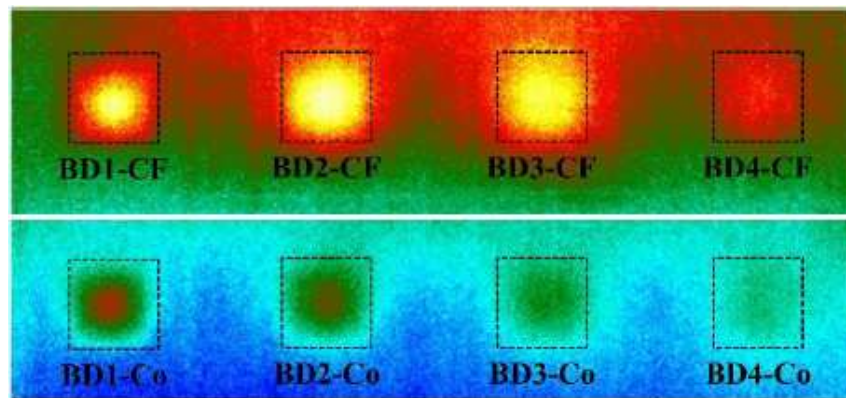
Figure 4.21: Thermograms for delaminations from the back face after 15 min heating and 20 min cooling in the CSC area (top); CWC area (bottom) (Mac et al. 2020).

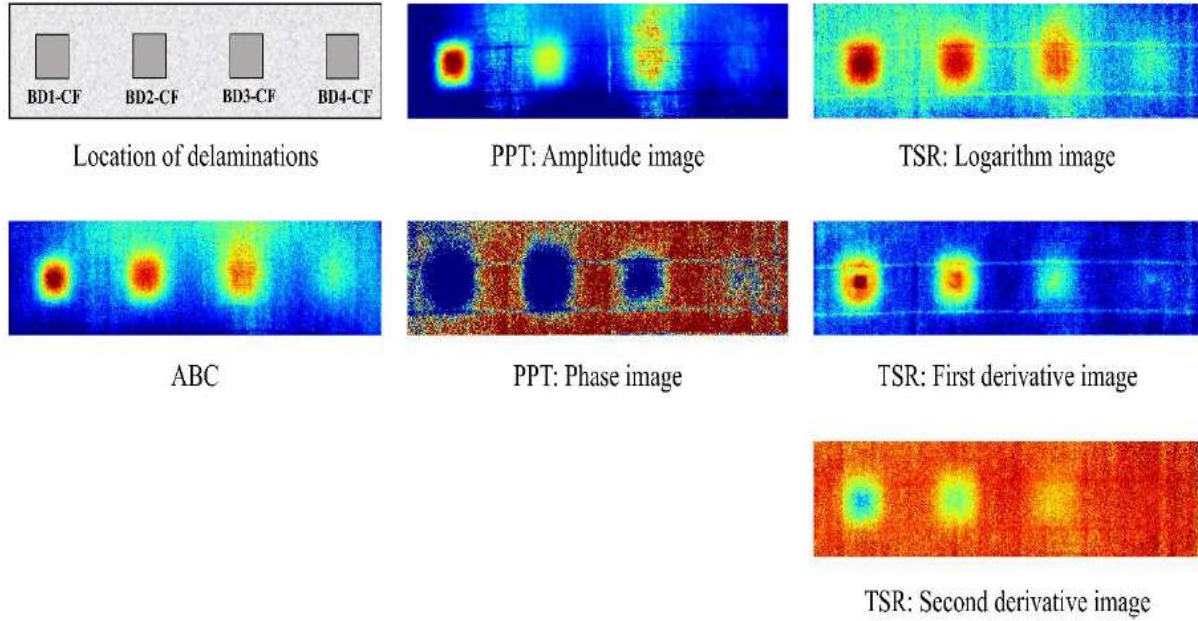
Figure 4.22: Comparison of thermograms (10 min heating for delaminations from the back face) processed using different algorithms (Mac et al. 2020).

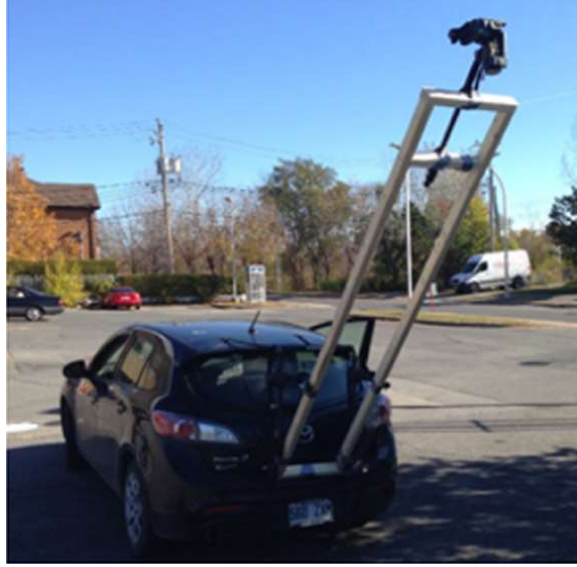
Figure 4.23: IR camera setup (Omar et al. 2018).

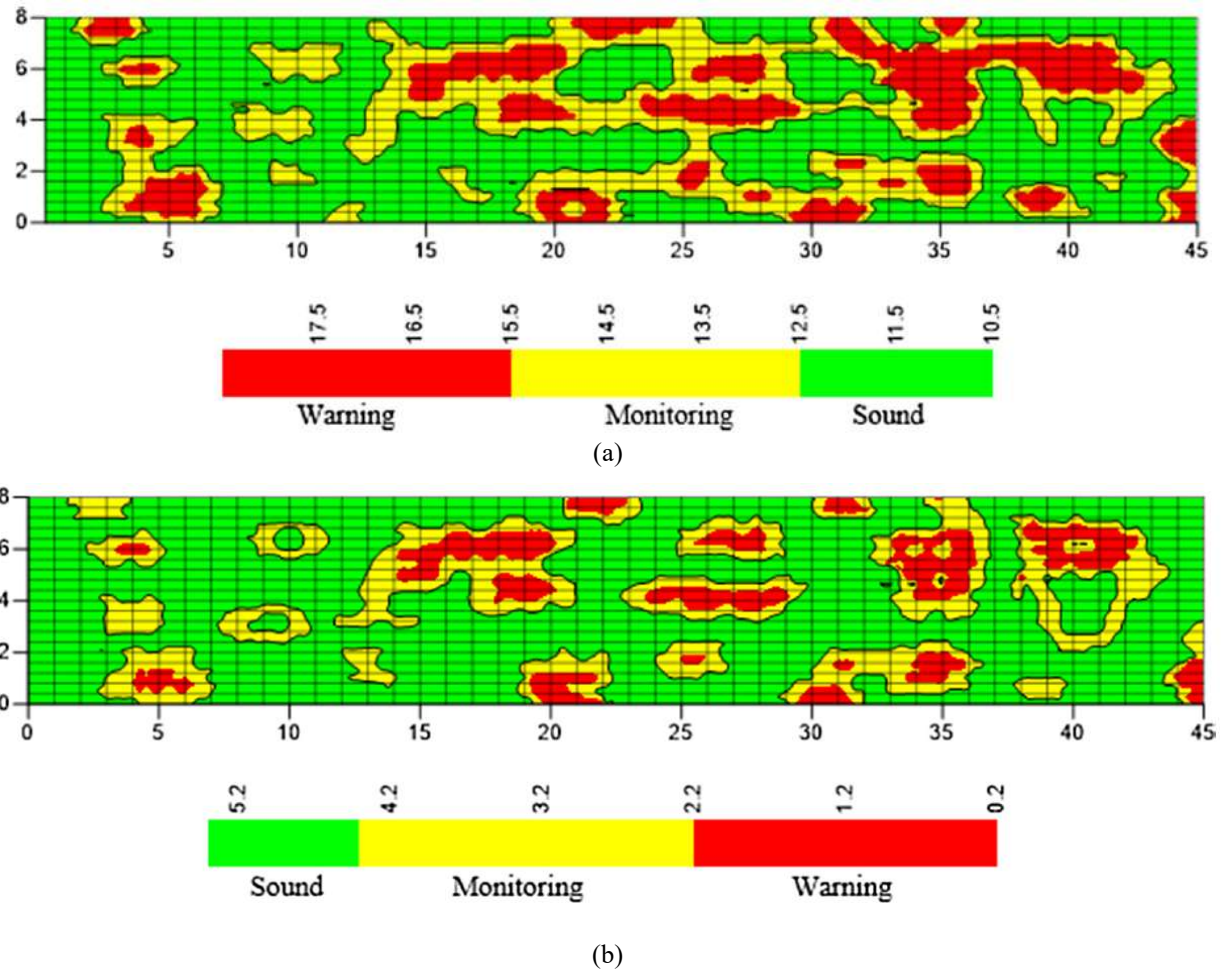
Figure 4.24: Condition maps of Montreal Bridge using thermograms collected during (a) day; (b) night (Dimensions in m) (Omar et al. 2018).

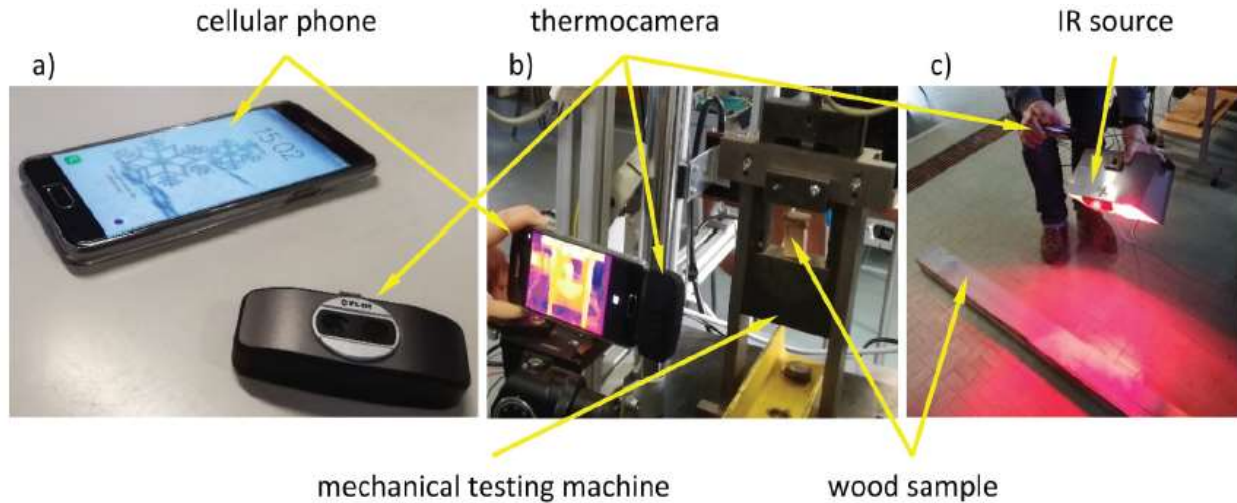
Figure 4.26: (a) FLIR ONE with the recording smartphone; (b) IRT setup for wooden block under compression testing machine; (c) IRT setup for wooden beam (Sandak and Sandak 2017).

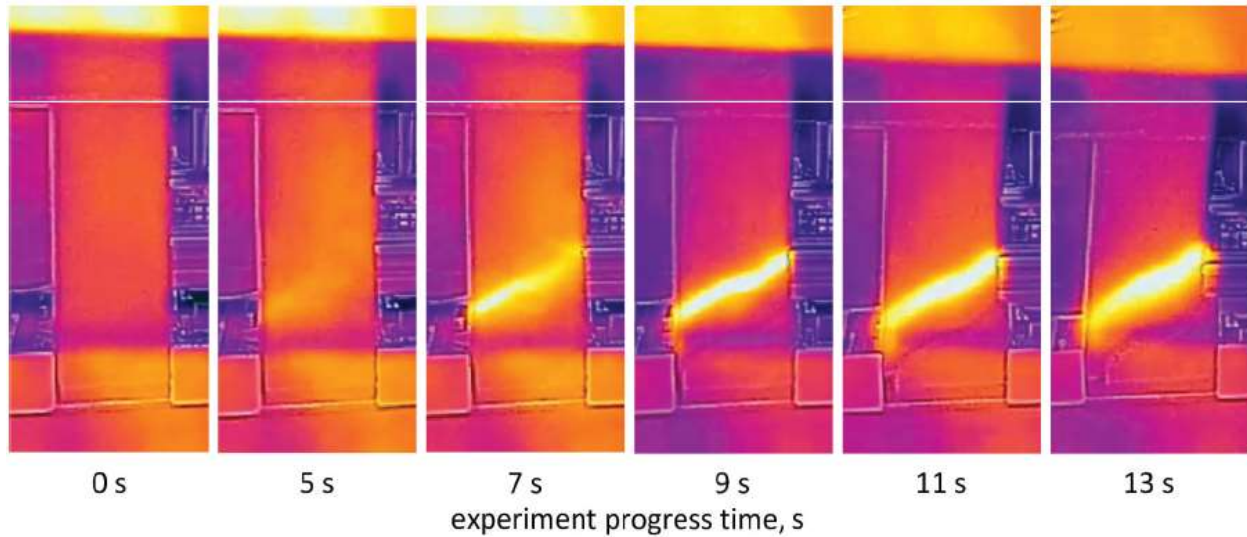
Figure 4.28: Wooden block specimen with recorded thermograms from passive IRT (Sandak and Sandak 2017).

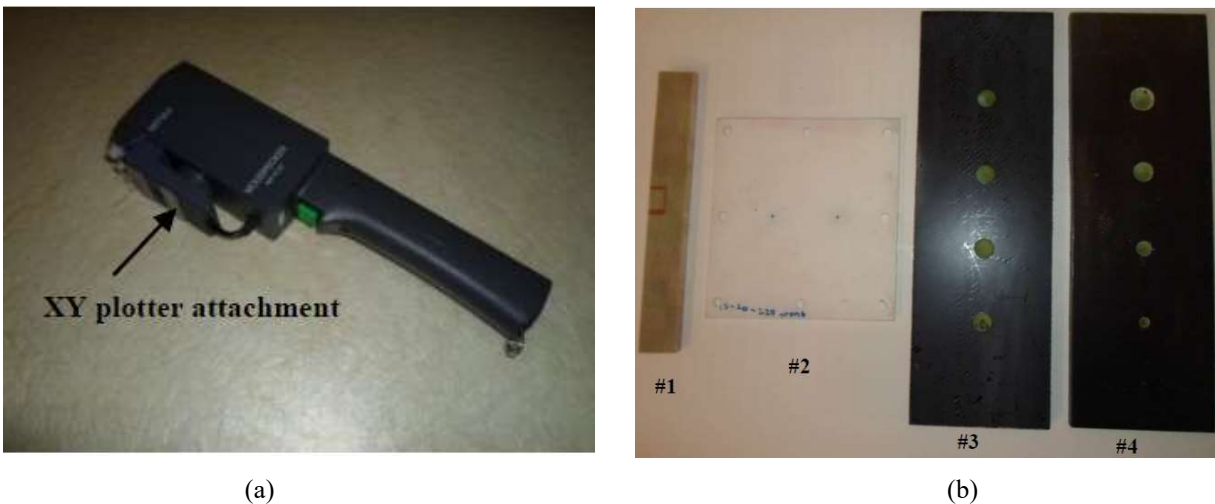
Figure 4.29: a) Woodpecker WP-632AM; b) Specimens used in the experiments (Gryzagoridis and Findeis 2013).

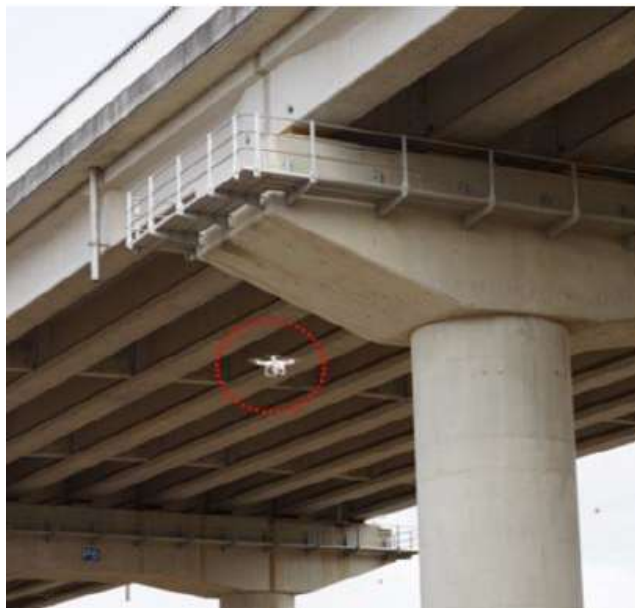
Figure 5.2: Field inspection site for the proposed device (Kim et al. 2015).

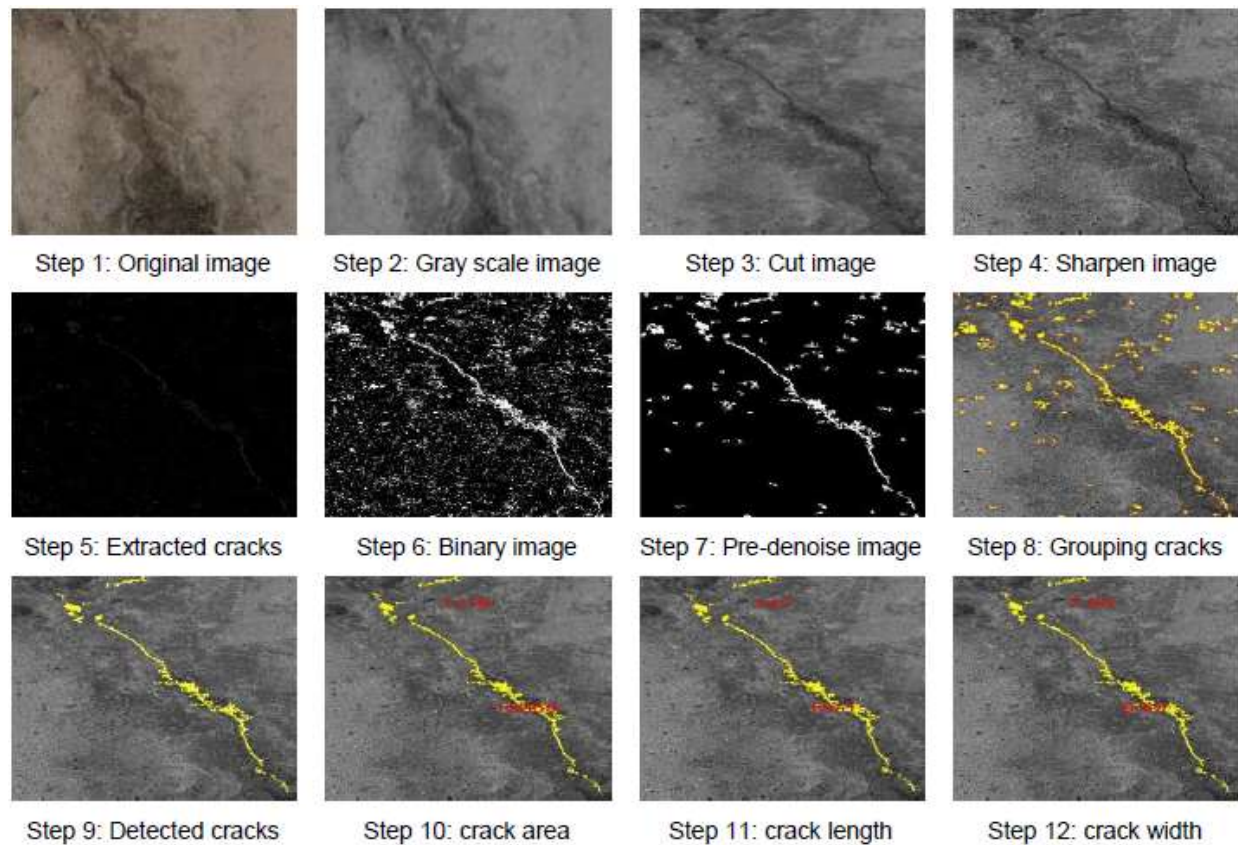
Figure 5.3: Crack analysis and quantification steps (Kim et al. 2015).

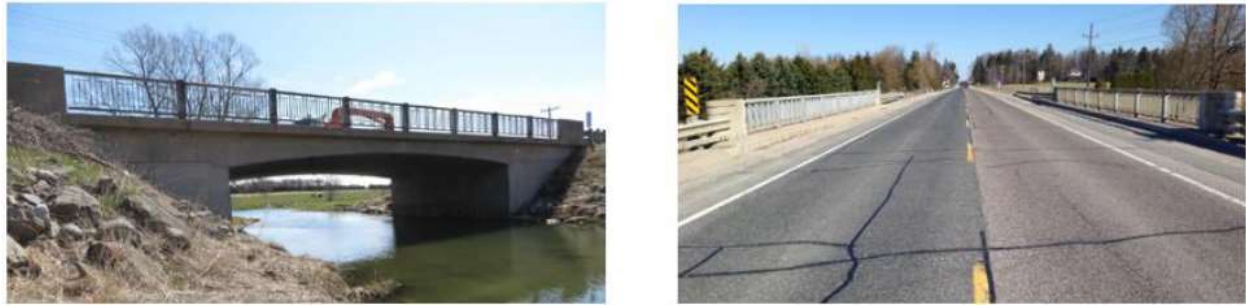
Figure 5.5: Bridge #2 testing site (Omar and Nehdi 2019).

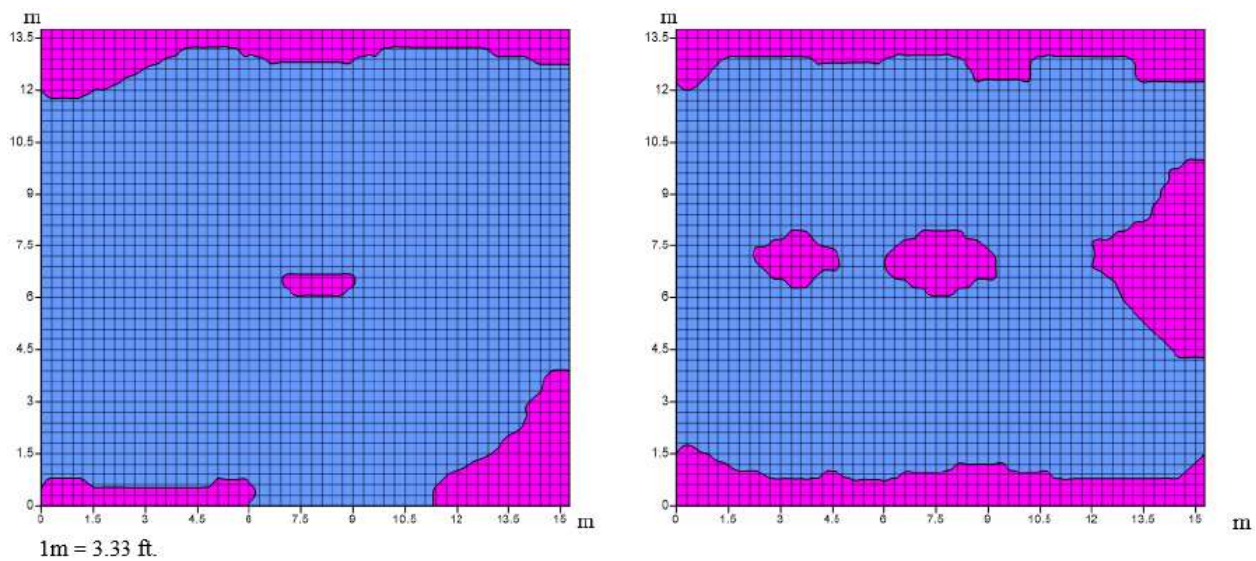
Figure 5.6: UAV-borne system condition map of (a) Bridge#1; (b) Bridge #2 (Omar and Nehdi 2019).

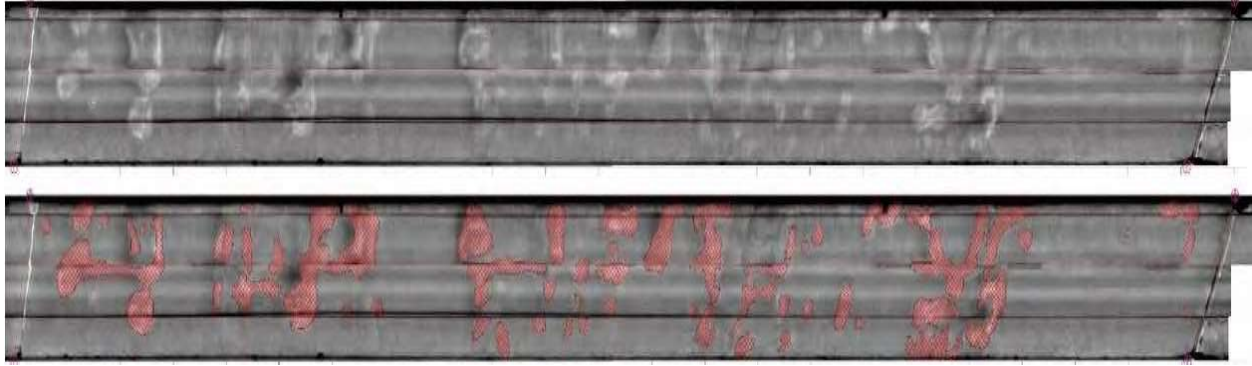
Figure 5.7: Bridge#4 vehicle-based raw image (top); condition map (bottom) (Guarino et al. 2018).

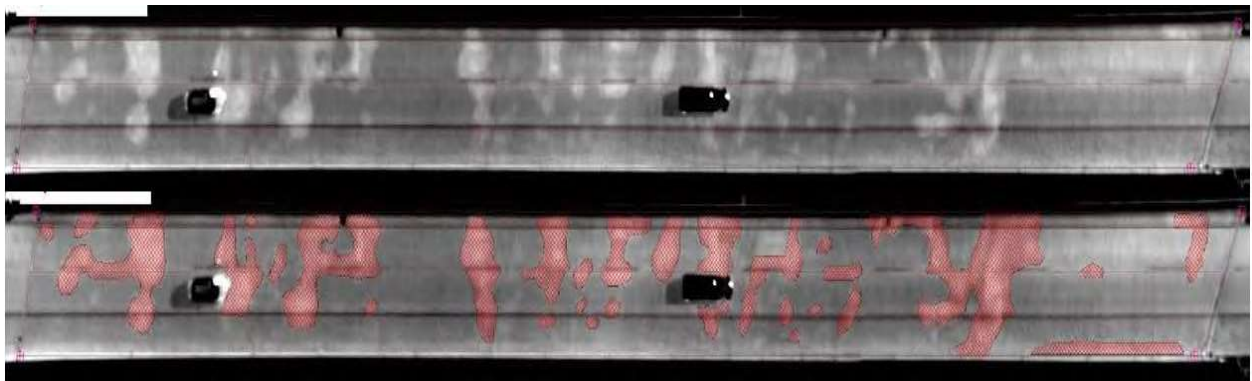
Figure 5.8: Bridge#4 aerial raw image (top); condition map (bottom) (Guarino et al. 2018).

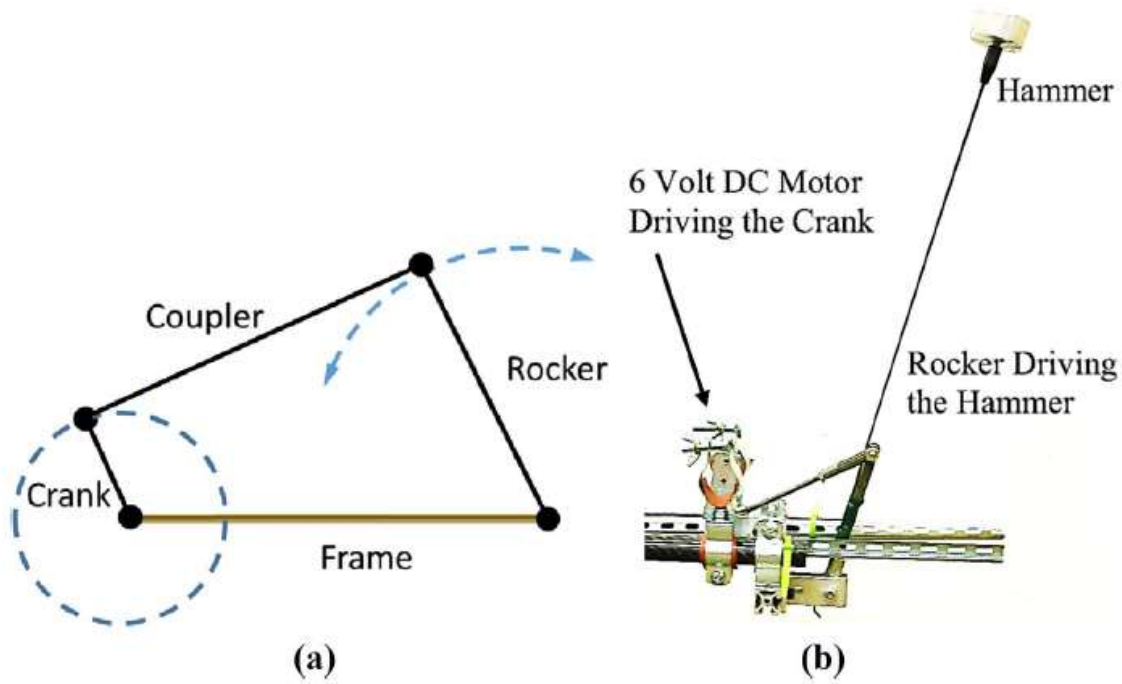
Figure 5.9: Tap hammer mechanism with a closed-loop and planar four-bar linkage (Moreu et al. 2018).

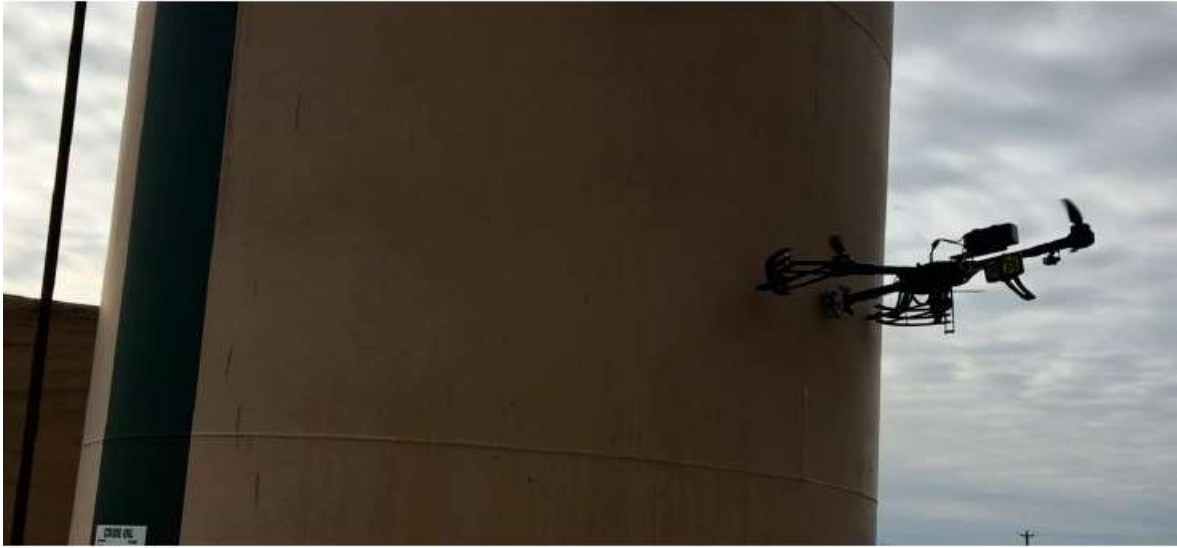
Figure 5.12: The proposed device taking measurements from the oil storage tank wall (Mattar and Kalai 2018).
